Streamlined sewer rehabilitation approach can save costs, hasten repairs

Ryan W. Hager

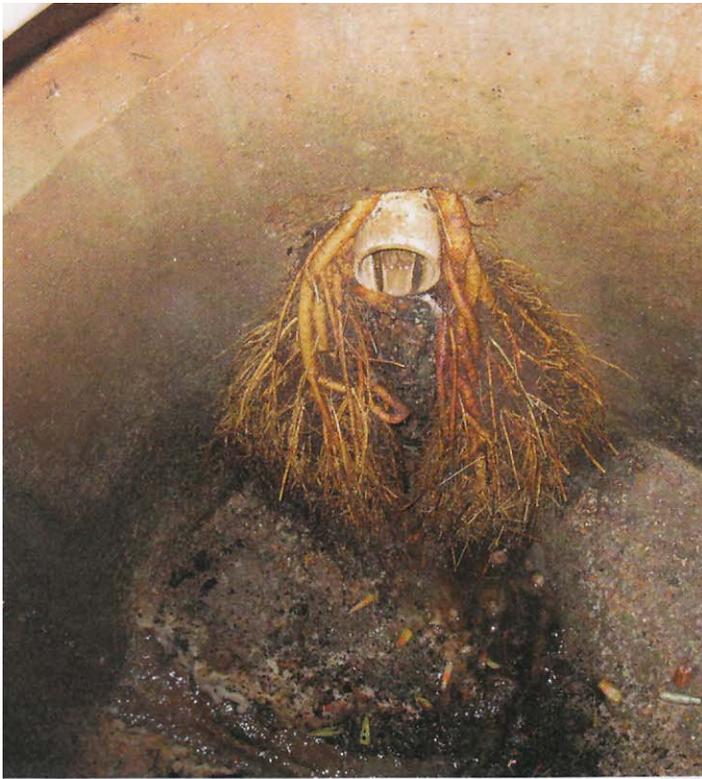
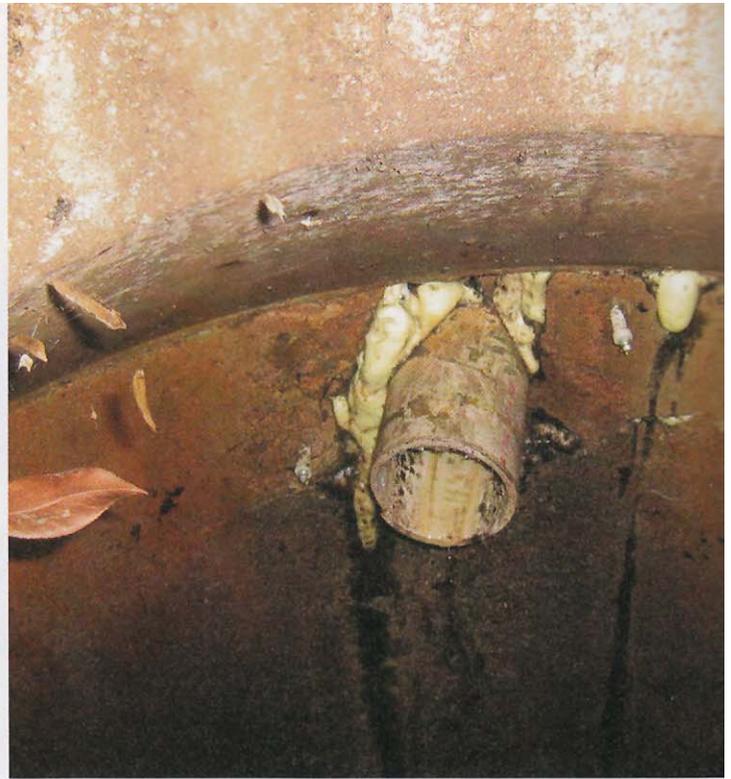
Pipes damaged by severe root intrusion (left) were repaired with injection grouting (right). W.K. Dickson

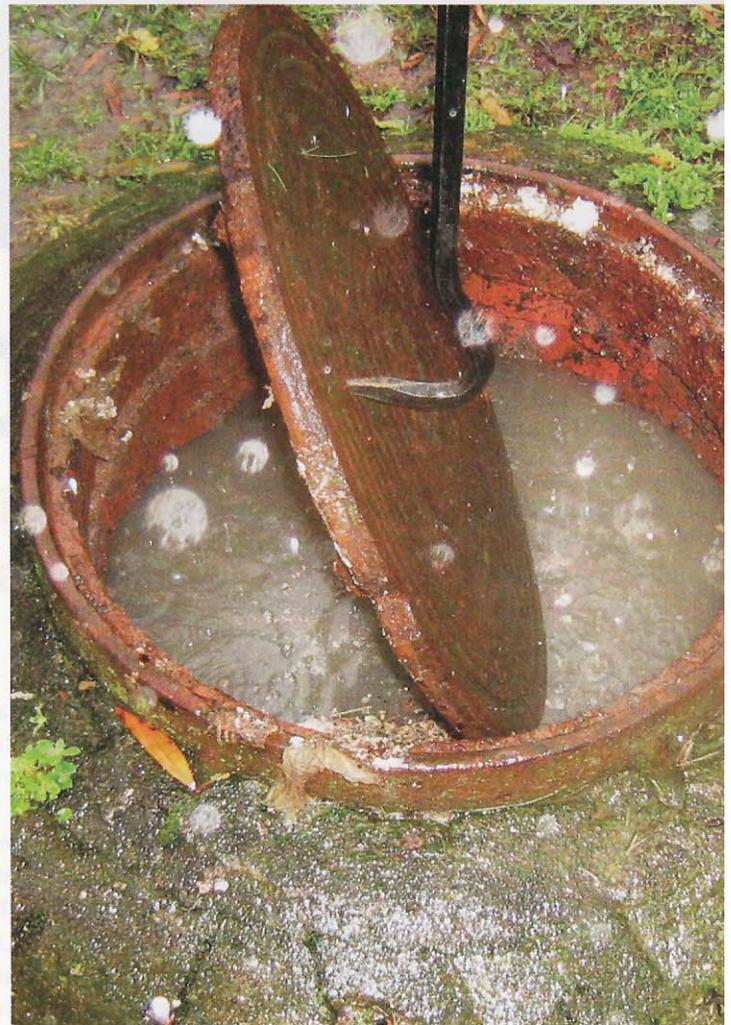
Prior to the repairs, water-filled manholes were common after moderate rain events. W.K. Dickson
